CONNECTICUT RIVER BASIN
WESTFIELD, MASSACHUSETTS

WEST PARISH FILTER NO. 3 DAM
MA 00610

PHASE I INSPECTION REPORT
NATIONAL DAM INSPECTION PROGRAM

MARCH 1981

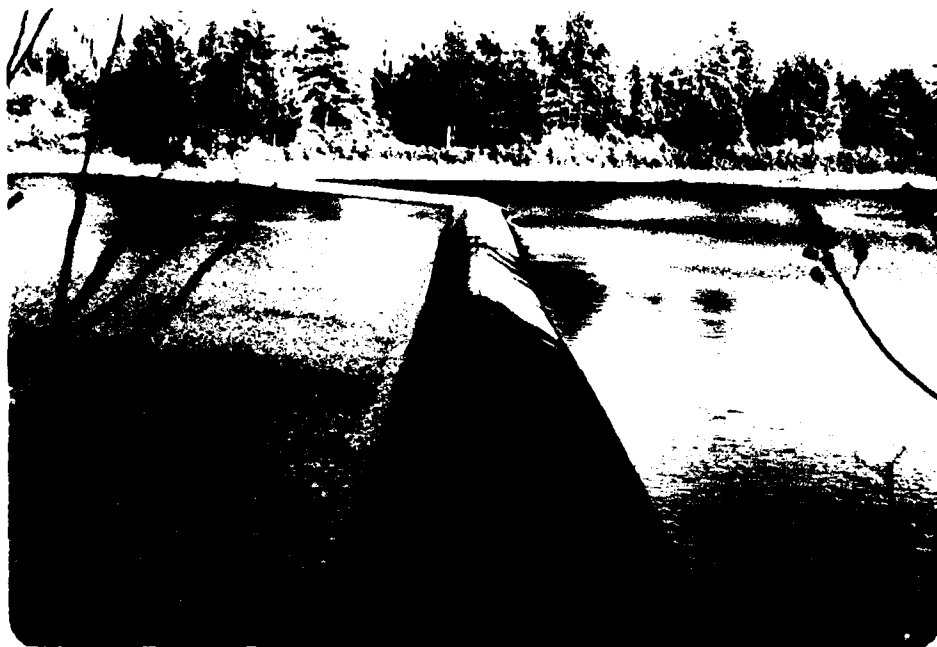
Photo No. 5

The timber crib structure in the reservoir was not judged to significantly affect the hydraulics. During a flood, small pool level differentials would exist, but there would be negligible effect. If the dam were to fail, there would be a very brief period when a significant pool level differential might exist. However, the timber structure has a thin cross-section, and failure of it would quickly ensue. As a result, failure conditions would only be modified slightly. The hydrologic and hydraulic computations performed for this report are included in Appendix D.

View of rock-filled timber crib structure which divides the reservoir into two sections.
